NASA TECHNICAL MEMORANDUM

N73-3/6/4 NASA TM X-2878

IRRADIATION OF THREE T-111 CLAD URANIUM NITRIDE FUEL PINS FOR 8070 HOURS AT 990° C (1815° F)

by Jack G. Slaby, Byron L. Siegel, Louis Gedeon, and Robert J. Galbo Lewis Research Center Cleveland, Ohio 44135

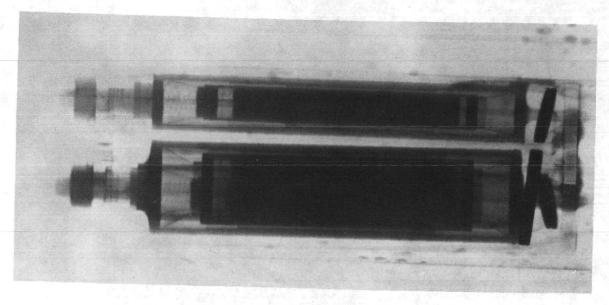
Clad integrity. - The capsules and fuel pins were punctured to check for the presence of fission gas. In two of the three pins fission gas was found only after puncturing the fuel pin, indicating that the pins did not leak. In the third pin, a half-diameter pin, fission gas was found after puncturing the capsule indicating a fuel pin leak. The leak was located in the thermocouple well of the fuel pin end cap containing the closure weld. The results of a liquid bubble type of leak test indicated a leak emanating from the base of the thermocouple well viewed from the fuel side of the end cap. The thermocouple well is an integral part of the end cap. Two smaller leaks were also observed in the face of the end cap (side also facing the fuel) in the vicinity of the seal weld closure. The seal weld was also leak tested. No leaks were detected in the top of the seal weld (side not exposed to the fuel). A photomicrograph of a metallographic section taken through the top end cap (thermocouple well wall and closure weld with filler wire) is shown in figure 13. The approximate magnification is X40. Note the leak path from the fuel side of the closure hole through the wall of the thermocouple well.

Figure 13. -Photomicrograph of fuel pin end cap showing leak path between thermocouple well and closure hole. X40.

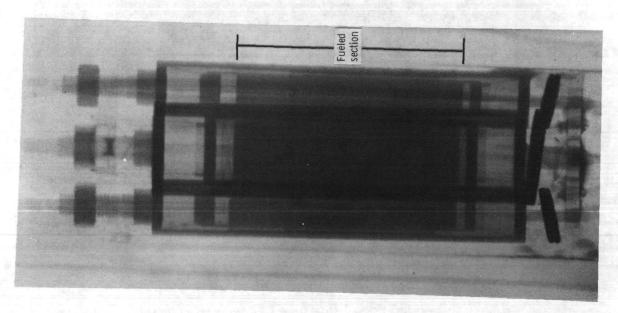
Neutron radiographs were taken before irradiation, after 4910 hours, and at the completion of testing (8070 hr). No fuel-pin clad swelling was indicated from any of the radiographs, and these observations were later verified during the postirradiation examination. The only change indicated in the neutron radiographs was the downward shift of the fuel stack caused by deformation of the spherical spacers provided for accommodating axial fuel expansion.

(b) Angle view showing reference-diameter fuel pin and one half-diameter fuel pin. Figure 14. - Neutron radiographs of irradiated fuel pin test assembly. Fueled section length, 5.715 centimeters (2.25 in.).

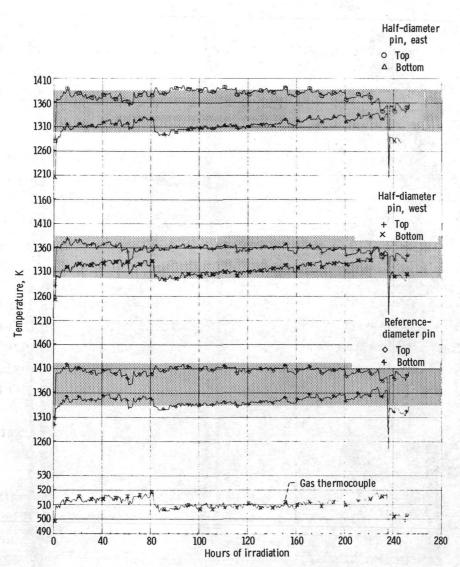
Figure 16. - Thermocouple readings for reactor cycle 110.

Listed at the top of figure 15 are factors that resulted in temperature variations between the fuel pins. The temperature variations of the fuel pins in the third reactor cycle (number 110) were considered to be as good as we could achieve. Figure 16 shows the temperature plots of the six fuel center thermocouples as well as the gas thermocouple plot. The gas thermocouple is a low-temperature backup couple located midway between the fuel pin and capsule end caps. The temperature plots were encouraging, and no further shield or rotational changes were contemplated. However, early in next reactor cycle, the hafnium power-flattening shield became dislodged from the capsule holder shroud. A large power increase occurred in the reference-diameter capsule approximately a factor of two at the location of the bottom fuel center thermocouple and approximately a factor of 1.2 at the location of the top center thermocouple. The calculated temperature at the bottom fuel center thermocouple resulting from the shield dropping off was approximately 1920 K (2996° F (above the melting point of type K thermocouples). The reference-diameter capsule four-wire bottom fuel center thermocouple failed during this temperature transient which lasted about 2 minutes. The experiment was automatically withdrawn during this temperature excursion. After a shield-attachment redesign was incorporated, the experiment was again irradiated. The bottom reference diameter fuel pin temperature was now determined from a relationship established between the bottom center thermocouple and gas thermocouple before the shield fell off. This calibration is discussed in appendix B. A significant observation from this irradiation is the large axial temperature variation that occurs over a distance of 3.8 centimeters (1.5 in.) - the distance separating the fuel center thermocouples. In many other experiments large temperature variations are not observed because the fuel pins usually do not contain thermocouples at different axial positions. In this test a determined effort was made to achieve uniform temperature on three fuel pins in the same test hole; yet, there were uncontrollable factors that precluded continuous operation
